Max Myanmar
Manufacturing Co., Ltd

Environmental Quality Monitoring Report for Limestone Mining at Taung Philar Mountain

Prepared by
HEXAGONAL ANGLE
International Consultants Co., Ltd.

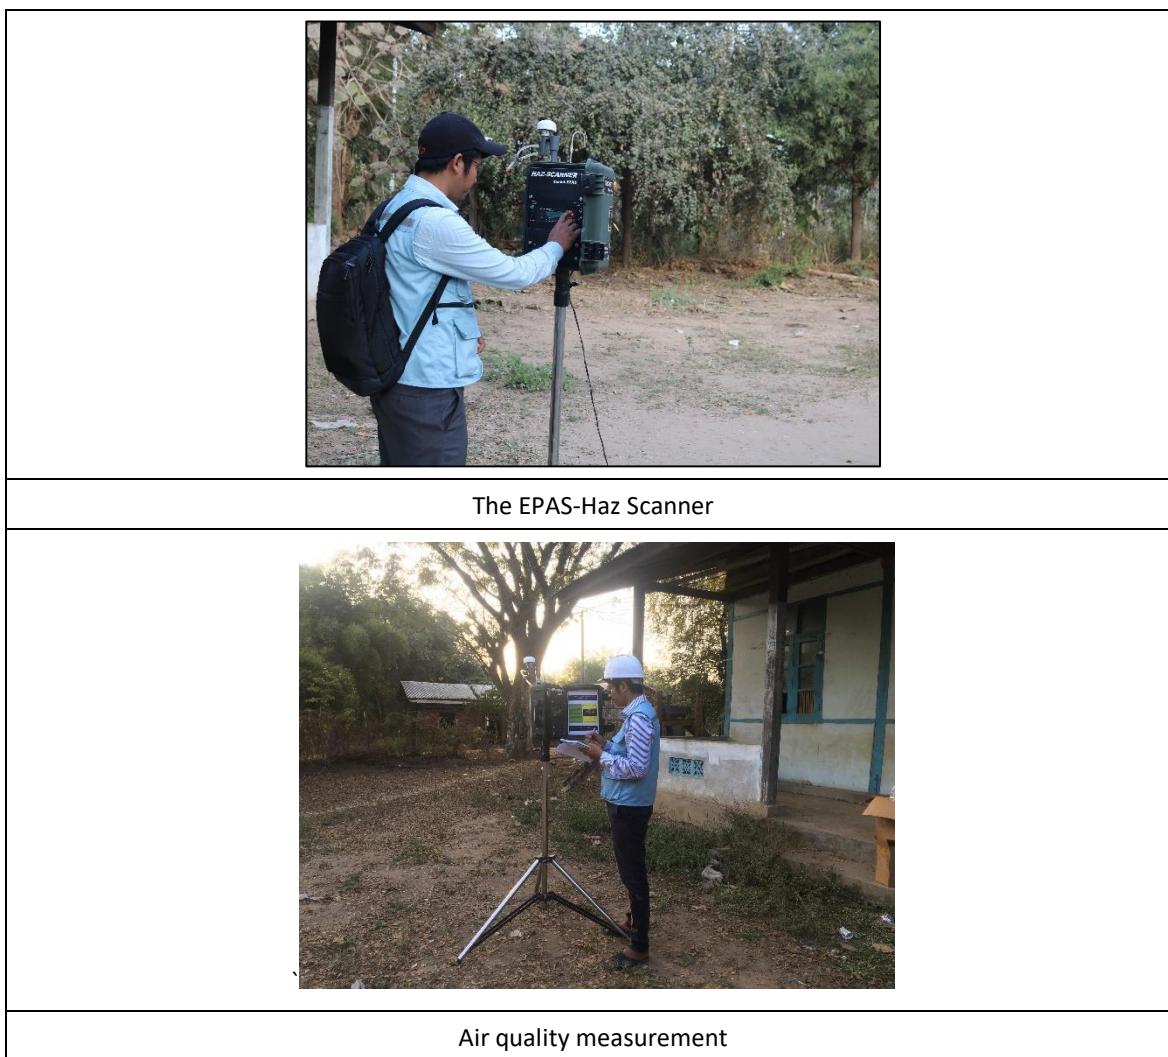
Figure 1-3 Air Quality Monitoring (24th to 26th December 2022)

By using the EPAS-Haz Scanner, the outdoor Air quality measurement was conducted from January 24th to 27th, 2022 at three locations, namely the limestone mining site which is 0.8 km far from the Max Myanmar Cement Factory, Aung Nan Cho village and Tae Kyi Kone village from 0.7 km and 0.9 km from the limestone mining site respectively. The air quality monitoring stations and measurement photos are described in Figure 1-2 and-Figure 1-3.

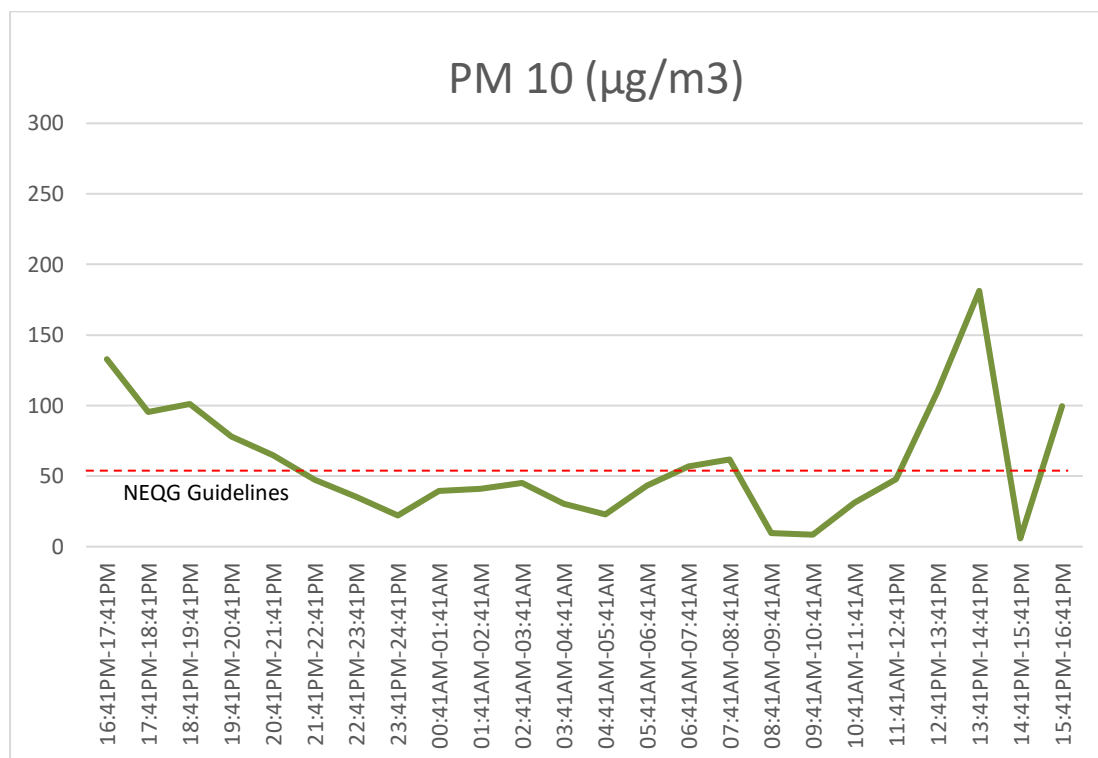
Figure 1-4 Graph for PM₁₀ Emission of Mining Site

According to the results, values of particulate matter (PM₁₀) and sulfur dioxide (SO₂) are above the NEGEG standard guidelines (Analyzed Graph is shown in Figure 1-4 ,Figure 1-5, Figure 1-6,

Figure 1-7,Figure 1-8 and Figure 1-9. Specifically, SO₂, and PM₁₀ are exceeding between 11:41 AM to 21:41 AM at mining site, between 4:28 AM to 7:28 AM at Aung Nan Cho Village and between 11:41 AM to 21:41 PM at Tae Kyi Kone Village respectively. These exceeding results in the atmosphere are caused by the operation of the limestone mining process. However, other parameters such as Nitrogen Dioxide (NO₂), Carbon Monoxide (CO) and other rest parameters are within the standard limitations. The results of the air quality measurements in the EMP report, 2016 are shown

Remark*:** PM₁₀ is exceeding above the guidelines due to the limestone mining operation process and vehicle movements. Compare to the previous measurement results at (2016), the current result of PM₁₀ is higher. Therefore, appropriate mitigation measure for PM₁₀ is required.

Mitigation Measure

- ✓ Do not clear the vegetation (and leave the ground bare) more than necessary
- ✓ Regular checkups and maintenance in vehicle and operation equipment
- ✓ Apply dust extractors, collectors, and filters at the drilling site; apply wet drilling if possible

- ✓ Do not blast when strong wind is blowing; blasting in the morning (07:00 - 08:30 hrs) generates less dust. Also consider meteorological facts (e.g., precipitation, temperature, wind direction)

- ✓ Also stop excavation, hauling, loading and unloading for a moment when strong wind is blowing
- ✓ If possible, apply wet processing at crushers and grinders (apply water sprays from time to time)

- ✓ Dust emissions from crusher, excavator, loader and dump truck will be adequately controlled through dust collectors, and water spraying
- ✓ Limit the drop height during unloading and loading the materials (gravel)

- ✓ If possible, use mobile and fixed belt transport and conveyors rather than hauling the materials (gravel) by trucks (use enclosed rubber-belt conveyors)

- ✓ Set up speed limit (slow speed) for truck to minimize emission of dust (a speed reduction from 30 km/hr to 15 km/hr will reduce 50% of dust emission)

- ✓ Spray water on un-paved road during dry months (wet suppression can greatly reduce dust emission up to 70%)
- ✓ Use and cover with tarpaulin to prevent the spill of gravel, overburden, and topsoil during transportation
- ✓ If possible, use water wash to minimize mud and dust track-out from the unpaved road area
- ✓ Regular cleaning of road surface by sweeping
- ✓ Use of windbreaker near the stockpile or plant rapidly growing vegetation around the mine site
- ✓ Avoid open burning of all kind of solid wastes; reuse and recycle them as far as possible and finally dispose them at approved land fill (dump site)
- ✓ Provide adequate PPE (masks, mouth and nose covers) to workers

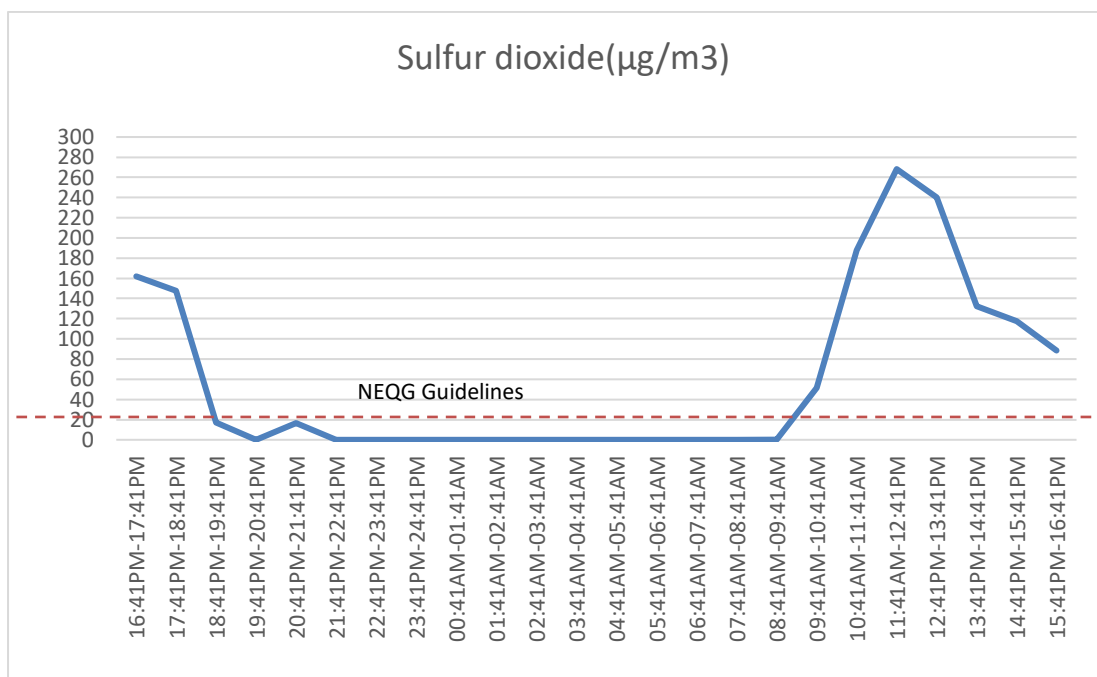
Figure 1-7 Graph for SO2 Emission of Mining Site Village

Remark: SO₂ is also exceeding above the guideline due to the limestone mining operation process and vehicle movements. Due to the use of fossil fuel (oil or gas fired power stations) as well as many chemicals, emissions from car and motorcycles where residential area, raw crusher, etc. The result of SO₂ emission is above the NEQG guideline according to the air monitoring result like the previous monitoring result of SO₂ at 2016. Therefore, the following appropriate mitigation measure to control SO₂ emission is required to implement during the operation period.

Mitigation Measure

- ✓ Regular checkups and maintenance on all vehicles with fossil fuel usage are needed.
- ✓ Use fuel oil with low Sulphur (if possible)

- ✓ Use environmentally friendly state of the art instruments and machines (such as engines with higher fuel efficiency, machinery that emit lower noise level), if possible
- ✓ Equip instruments, machines, and vehicles with air pollution control devices to minimize exhaust emissions. (These may not available but should be considered in advanced for the near future)
- ✓ To conserve fuel and to prevent unnecessarily emission of gas (smoke) never let vehicles and instruments left running unnecessarily
- ✓ Avoid open burning of all kind of solid wastes; reuse and recycle them as far as possible and finally dispose them at approved land fill (dump site)
- ✓ Provide adequate PPE (masks, mouth and nose covers) to workers

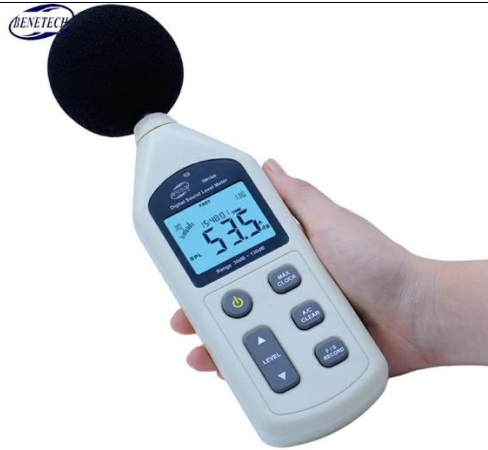
Figure 1-10 Equipment Used to Measure Noise Levels

GM-1356 Digital Sound Level Meter

It is used for measuring noise and other sounds in the project factory.

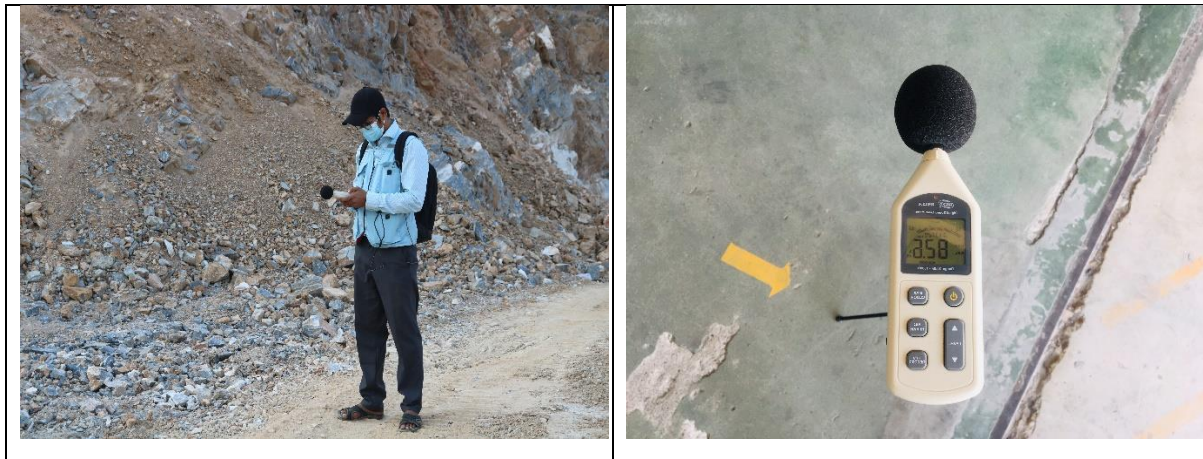
Figure 1-12 Noise Level Measurement in the Mining Site

In measuring noise at the mining site, it is noted that minimum noise level at daytime is 33.08 dBA and at night time is 36.2 dBA. The maximum noise measurement results at the mining site are 86 dBA at daytime and 60.2 dBA at night time. There are heavy activities in the loading/unloading place and raw crushing process. The average noise level at mining site is 65 dBA at daytime and 40.8 dBA at night time. Thus, the average noise measurement results are relevant to the standard noise level.

In measuring noise at Aung Nan Cho village, the average noise level at day time is 65.5 dBA and average noise level at night time is 54.8 dBA. It is exceeding a little bit above the NEQEG guideline values due to the moving of motorcycles and trucks at day time and young people play guitar at night time near the noise measurement. In measuring noise measurement at Tae Kyi Kone village, the average noise result is under the guideline, specifically noise level at day time is 48.3 dBA and average noise level at night time is 43 dBA. The measurement results are in Table 1-6 and Table 1-7 respectively.

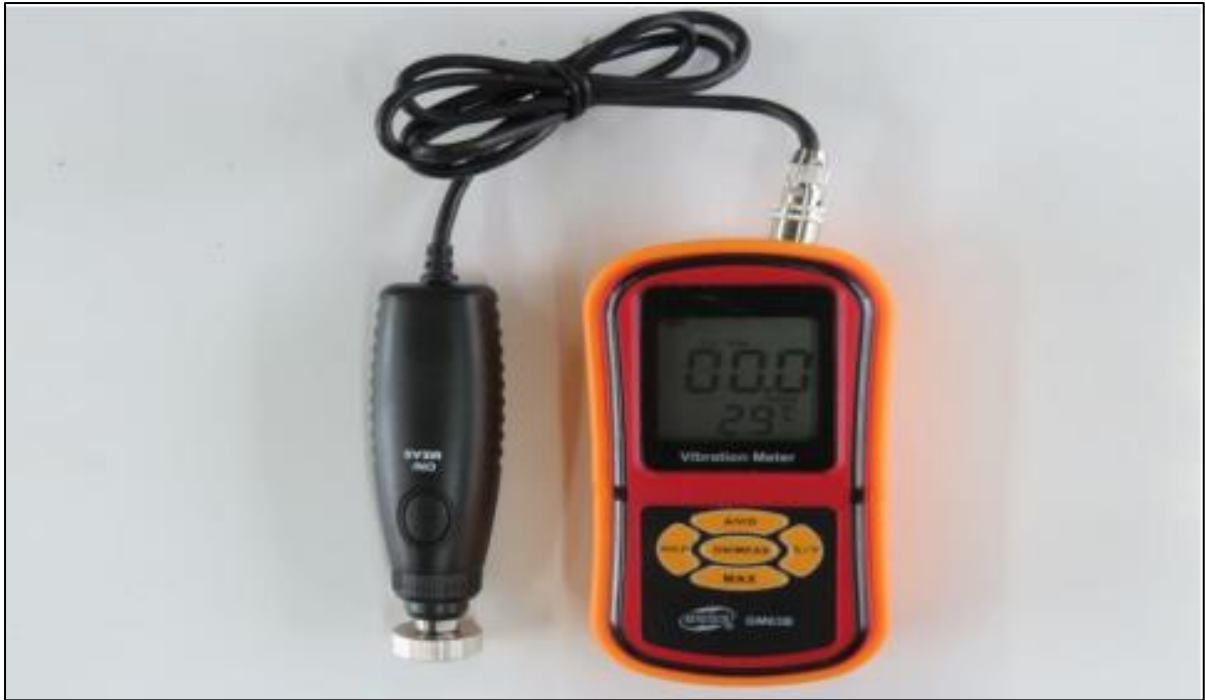
Figure 1-13 Vibration Meter

BENETECH vibration meter was used for measuring vibration at the same points for air quality measurement and noise level measurement, specifically at the mining site, Aung Nan Cho village and Tae Kyi Kone village. The current measurement results are 4.5 mm/s at mining site, 2.4 mm/s at Aung Nan Cho village and 1.1mm/s at Tae Kyi Kone village. But vibration due to blasting is instantaneous (very temporary). The results of the vibration measurement in the EMP report, 2016 were 2.3 mm/s at the mining site, 1.8 mm/s at Aung Nan Cho village, and 1.5 mm/s at Tae Kyi Kone village respectively. Thus, the vibration results do not change so much in the current situation. Equipment used for measuring vibration is Figure 1-13. The measurement made in the field visit are shown in Figure 1-14. The location of vibration measurement points map is shown in Figure 1-15.

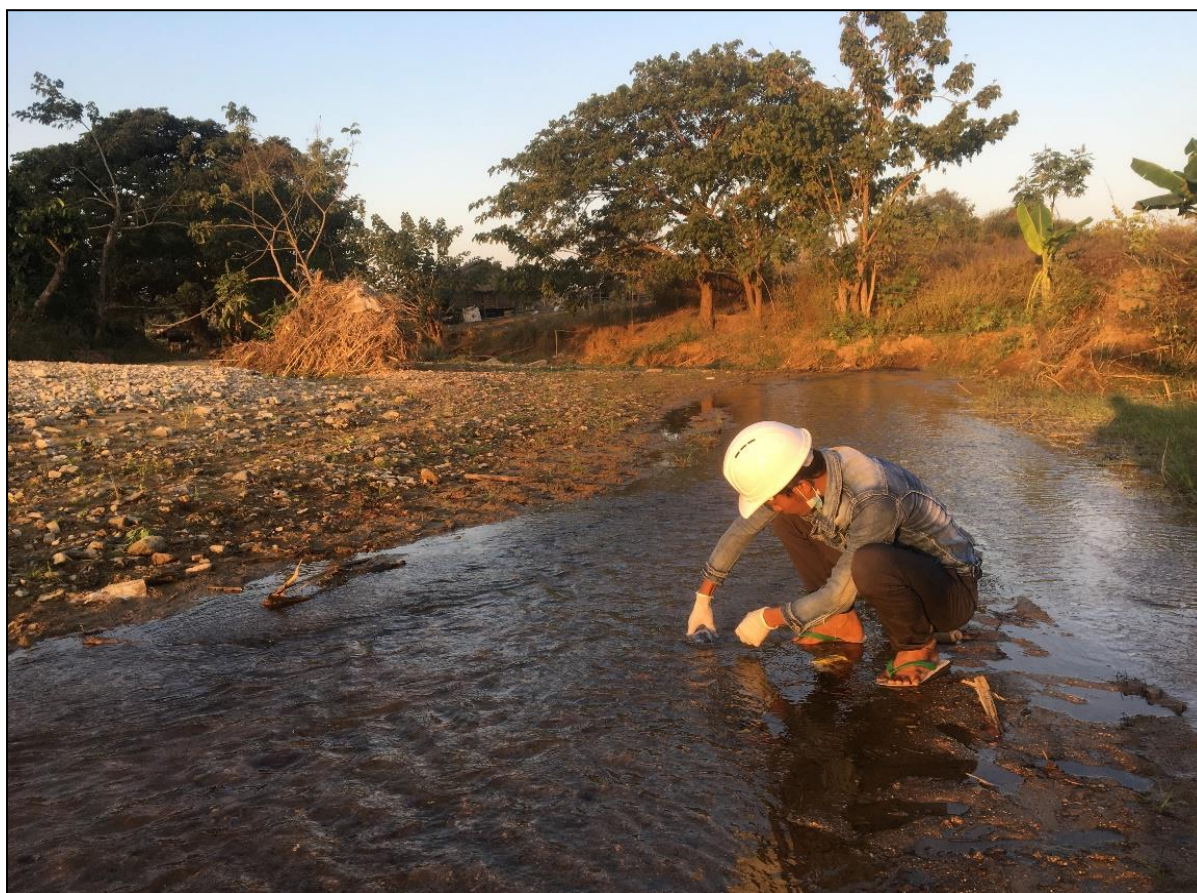
Figure 1-16 Water Sample Collection from Yay Pu Stream

Water sample was collected in the Yay Pu stream which is Lat. 19° 31' 12.00" N, Long. 96° 24' 5.63" E. As the lime stone mining production process does not produce wastewater, the stream water samples were collected to know the water quality of the mining site environment as shown in Figure 1-16. The process was conducted on 25th and 26th January 2022 then sent to the laboratory. As the result, pH level of water is on the margin of the standard value and the other parameters such as COD, BOD, Total Suspended Solids, Phosphate, Nitrate (N.NO₃) and Oil & Grease are under the guideline. Water sample collection map of Max Myanmar Manufacturing Co., Ltd is shown in Figure 1-17. The results of current water quality and previous water quality are shown in the following Table 1-10 and compared with the guideline value of NEQEG Effluent Guideline values prescribed by ECD, original laboratory test result is attached in **Appendix B**.

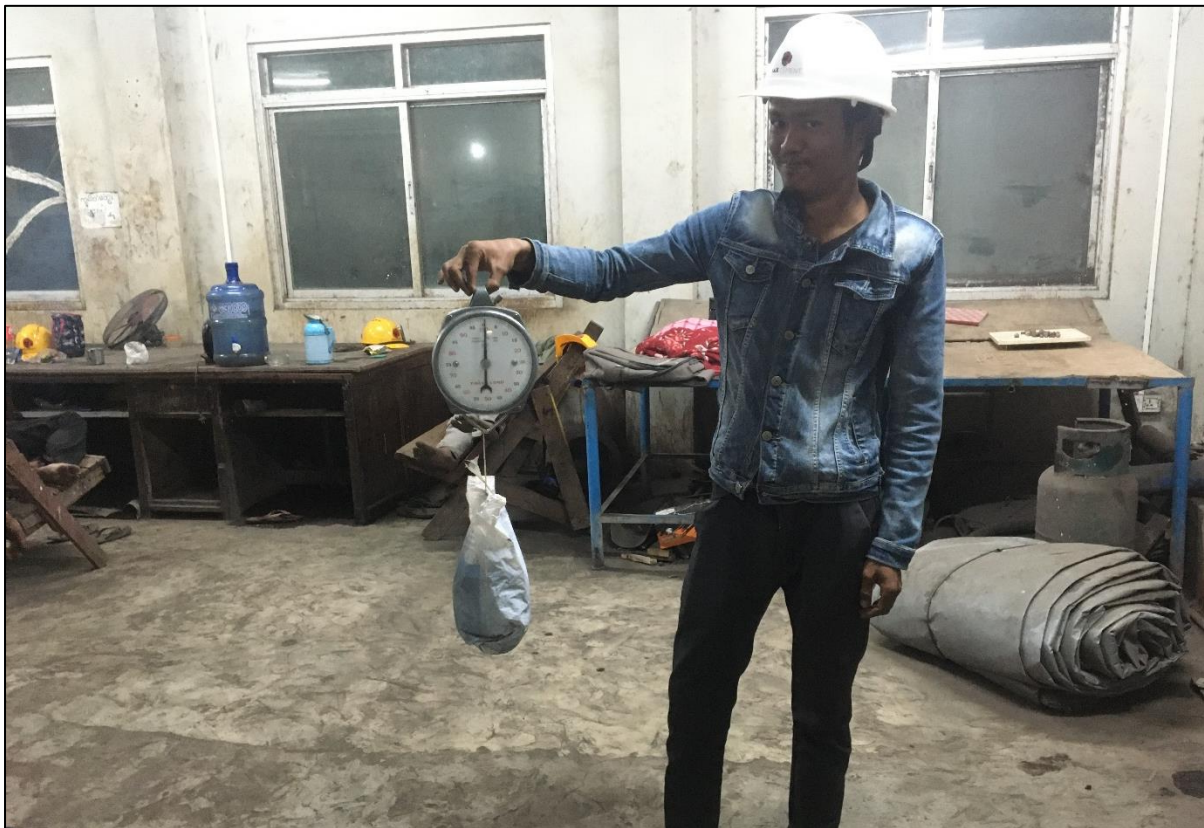
Figure 1-19 Solid waste generation measurement photo

The average domestic waste generation results are 0.01 kg per person/day in office and 0.03 kg per person/day in staff accommodation respectively. Moreover, domestic wastes are disposed to the disposal site inside the project area one time per day and leftovers from workers' food are used as animal foods. The domestic waste generation measurement photo is shown in Figure 1-19 and the domestic waste measurement result graphs are shown in Figure 1-20 and Figure 1-21.

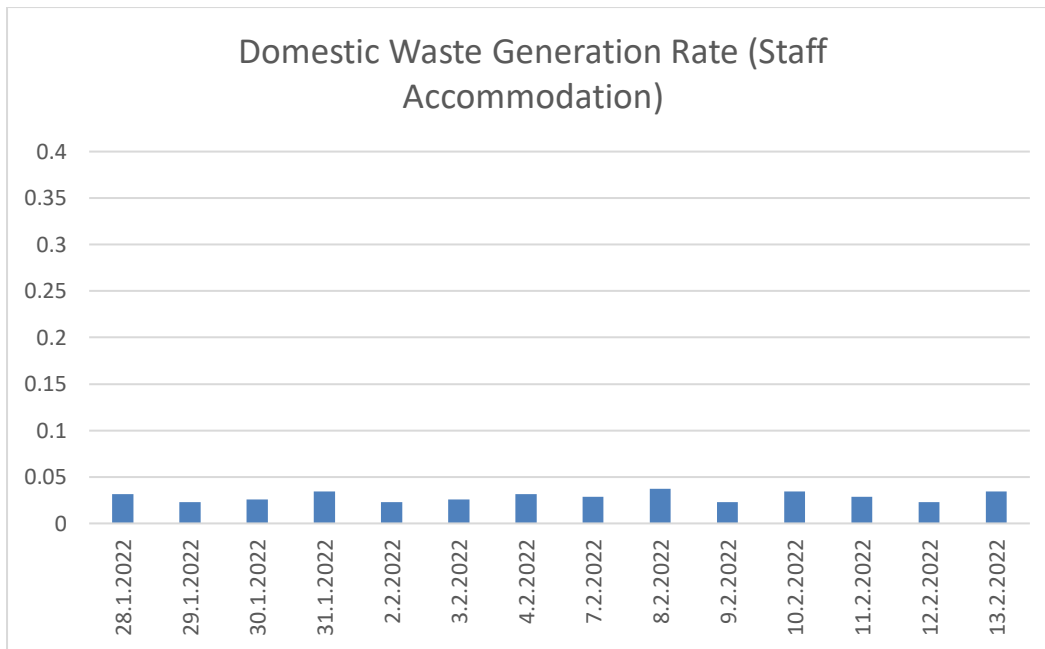
Figure 1-20 Domestic Waste measurement results graph (Staff Accommodation)

Remark: The current average waste measurement rates in staff accommodation and office are low. The reason for these rates is due to the food wastes are used as animal food.
